Draft
Site Visit Report
Coalbed Methane Operations
Gillette, WY

Eastern Research Group, Inc.

August 21, 2001

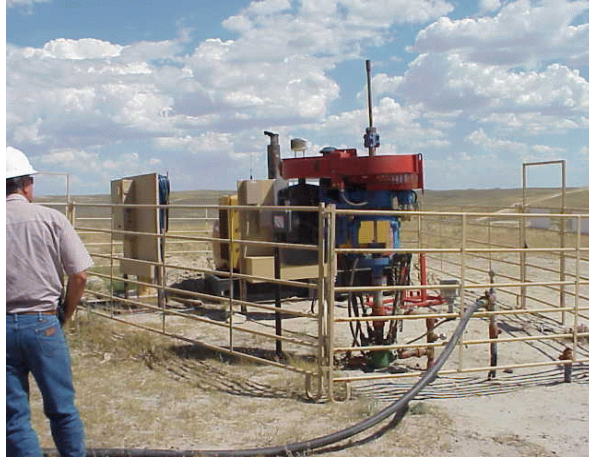
Figure 1: Progressive Cavity Pump at Scooner Road

Barrett Resources Corporation is conducting a pilot CBM operation at this location that started in March 2001. The pilot project is to test the effectiveness of using atomizers to disperse the produced water and increase vegetative growth. At this location, Barrett Resources operates 15 CBM wells that are drilled to a depth of approximately 2,000 feet into the Big George coal formation. This location represents the deepest part of the Powder River Basin. The wells are spaced at one well per 80 acres. These wells currently produce approximately 50 to 60 gallons per minute (gpm) of water per well. The water is pumped up from the well using a progressive cavity pump. Figure 1 shows a picture of one of the wells with a progressive cavity pump. The produced water is piped to a large reservoir and storage tanks. Figures 2 and 3 show pictures of the produced water reservoir and storage tanks. The overflow of the tanks is piped to one of eight atomizers that have a fixed point sprinkler head. The atomizers can accommodate up to 60 gpm of water. Figure 4 shows a picture of one of the atomizers.

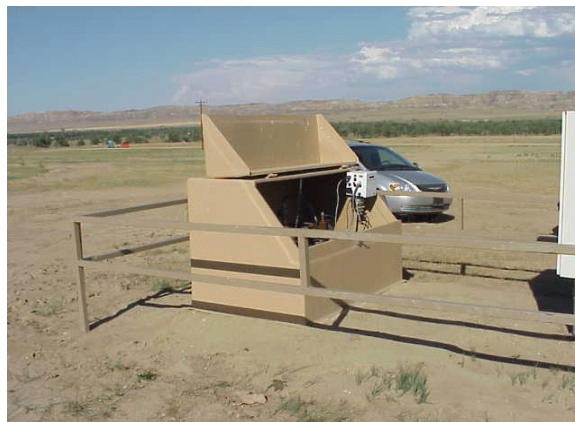
Figure 5: Well Head and Frost Box at Kuhn Ranch

Pennaco Energy is operating CBM wells at this location. The wells are open hole cavity wells with a submersible pump. Frost boxes are installed over the well head to protect them from the elements. At this location, there was also a telemetry box for the well. Figure 5 shows a picture of the well head inside the frost box and Figure 6 shows a close-up picture of the well head.

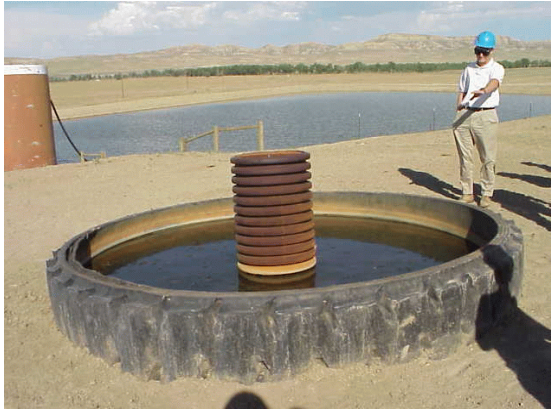
Figure 7: Tire Tank at Tietjen Ranch

Pennaco Energy is operating CBM wells at this location. The produced water is managed in a number of different ways. Some the water is piped to a tire tank and used for livestock watering. Figure 7 shows a picture of the tire tank. Some produced water is piped to storage tanks and used for water enhancement work on the CBM wells. Enhancement work includes flushing the wells to remove coal fines that may be pumped up with water. Figure 8 shows a picture of the storage tanks. The remainder of the produced water from this location is piped into an evaporation pond. The water is discharged out of a perforated pipe and over limestone rocks (i.e., rip rap) to precipitate out the dissolved iron before the water reaches the pond. The precipitated iron causes red staining. By inducing the precipitation over the rocks, the staining can be limited to the rocks which can be removed and permanent staining of the ground is eliminated. Figure 9 shows a picture of the rip rap and evaporation pond.

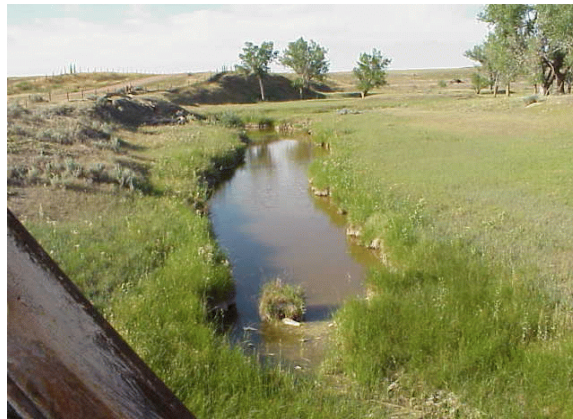
Figure 10: Wild Horse Creek

Wild Horse Creek is a Class 4 tributary to the Powder River located near Arveda, Wyoming. CMS Energy discharges approximately 1,344,000 gallons per day (gpd) into Wild Horse Creek from 290 CBM wells. There are also approximately 400 additional CBM wells being discharged to this creek from other operators. Due to evaporation and infiltration of the produced water into the shallow aquifers, the water flow in Wild Horse Creek is relatively slow. Figure 10 show a picture of Wild Horse Creek, about a quarter of a mile from its discharge into the Powder River.

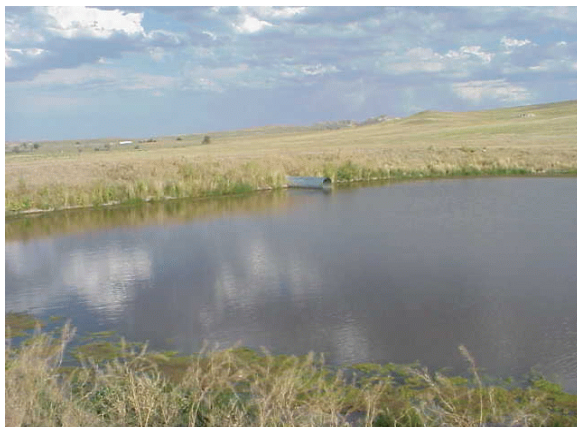
Figure 11: CMS Water Reservoir

CMS Energy operates a number of CBM wells within the drainage to Wild Horse Creek. Figure 11 shows a picture of a CBM produced water reservoir. The water from the reservoir drains out into an empheral unnamed tributary of Wild Horse Creek. This tributary, near the discharge point has been lined with rocks to minimize erosion. Figure 12 shows a picture of the drainage onto rocks for erosion control and Figure 13 shows a picture of the unnamed tributary.

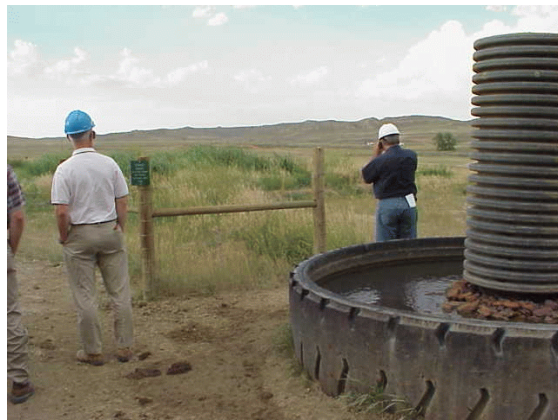
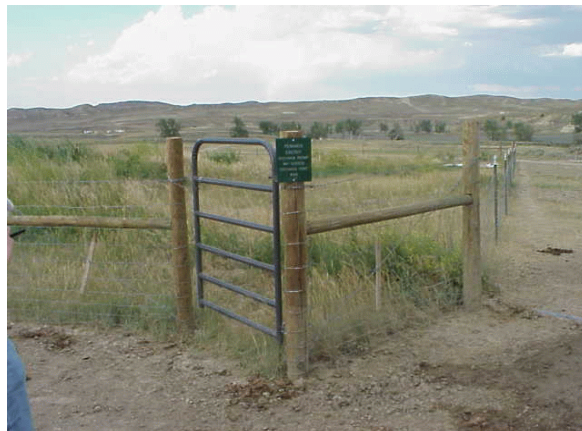
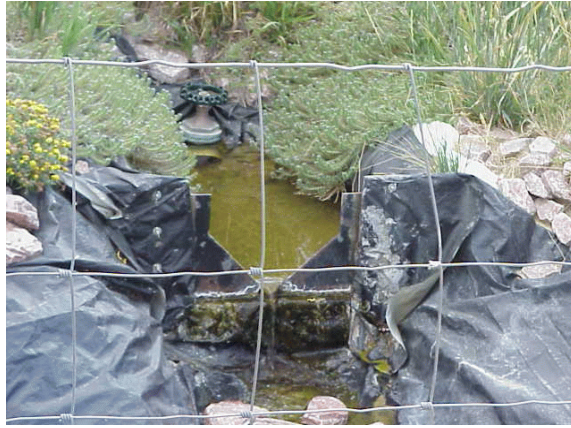
Pennaco Energy is evaluating the potential to remove iron and barium in Carex (sedge)-dominated wetlands that are common in ephemeral drainages in northeastern Wyoming. The Felix pilot study is being conducted in an off-channel constructed wetland. The wetland treatment design consists of passive (abiotic) oxidation of ferrous iron to ferric which is conducted as water flows out of the pipe in the tire tank, followed by filtration through dense stands of native sedge, and then filtration through a sand bed. Finally, the water is discharge to the receiving stream. Figure 14 shows a picture of the tire tank and wetland area and Figure 15 shows a picture of the wetland area. Figure 16 shows a picture of the water flowing through the down gradient end of the wetland towards the sand bed filter and Figure 17 shows a picture of the sand bed filter. Figure 18 shows a picture of the discharge point to the receiving stream.

The native sedge (i.e., *Carex utriculata* (rostrata), *C. aquatilis*, *C. nebraskensis*) was planted in June, 2000 with one-foot spacing between plants. The wetland is designed to accept a flow of 30 to 40 gpm and the hydraulic residence time is estimated at one day. Preliminary findings indicate that iron removal is excellent but that barium removal is less efficient. Since the barium in the produced water is in an ionic carbonate form, a longer residence time may be required to allow the barium to recombine with sulfate and precipitate. Constructed wetlands are not expected to reduce the sodium adsorption ratio (SAR) of the produced water due to the short-residence time. Ancillary wildlife benefits appear excellent based on the enhancement of the wetland-riparian habitat.

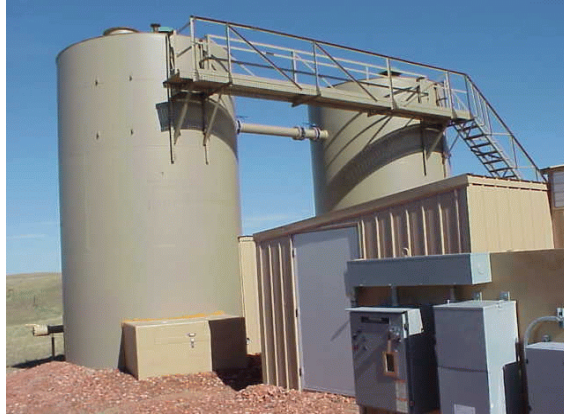
Figure 19: Treatment Facility at Jim Wolfe Ranch

Joe Olson of Pennaco Energy presented an overview of this location. At this location, Pennaco Energy built an aquifer storage and retrieval facility that was never put into operation. The facility cost approximately \$450,000. Figure 19 shows a picture of the treatment facility. The facility is designed to collect produced water from 60 CBM wells into a water storage tank. Figure 20 shows a picture of the water tank. As the water enters the tank it hits a splash pan to facilitate separation of water, sediments, and methane gas. The water would then enter the treatment facility and flow through an ultraviolet light chamber with 32 bulbs arranged in a circular pattern. Figure 21 shows a picture of the ultraviolet light chamber. The system, however, was designed to handle a flow of approximately 1,000 gpm and the highest actual flow from the 60 wells was 380 gpm. The reduced flow resulted in biofouling of the bulbs and, therefore, light never reached the water. Pennaco Energy also found high sulfate concentrations in the produced water which prevented the water from being reinjected into the planned aquifer.

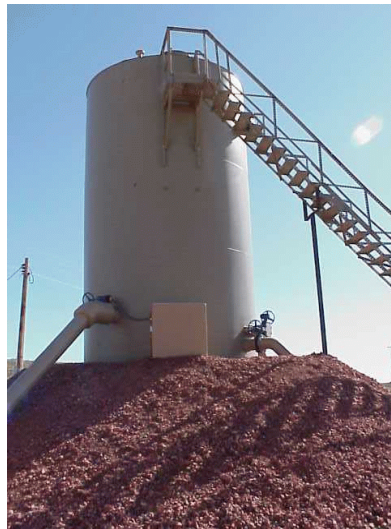
Figure 20: Water Tank at Jim Wolfe Ranch

To manage the produced water from the 60 wells, Pennaco is collecting the water in the storage tank, metering the water, adding chlorine to disinfect the water, and piping the water to four injection wells in the area. Currently only two injection wells are being used. These injection wells are reclaimed oil and gas wells that were abandoned. Gravity flow is used to move water into the injection wells, which reduces cost. The water flow is now down to a third of the initial production flow.

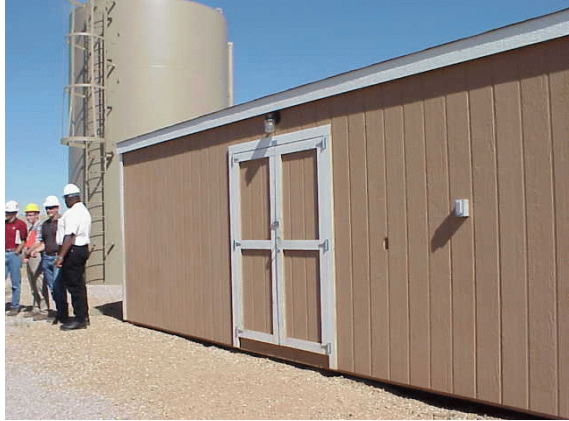
Figure 22: Steinhopfel Facility

Pennaco Energy is operating a reinjection facility at this location because the landowner will not allow surface discharge on his property and reinjection was economically viable. This facility has been operating for approximately 1.5 years and has reinjected over 140 million gallons of water. Figure 22 shows a picture of the facility. Produced water from approximately 20 CBM wells is collected into a tank where it hits a splash pan to facilitate separation of water, sediments, and methane gas. The water is then metered and chlorine is added to disinfect the water. The water is then piped to a series of four injection wells. Only two injection wells are currently being used. The initial flow of the produced water was 280 gpm. The current flow is about 100 gpm. This facility cost approximately \$120,000 to design and operate. Only one well has required rehabilitation to date. It is economically viable because the injection wells are downgradient from the facility and gravity feeds the water down into the injection wells which were abandoned oil and gas wells. This is possible because the aquifer is approximately 40 percent depleted . Pennaco Energy estimated that it would cost approximately \$50,000 to install pumps to inject the water if the injection wells were not located downgradient of the facility and the receiving aquifer was not depleted.

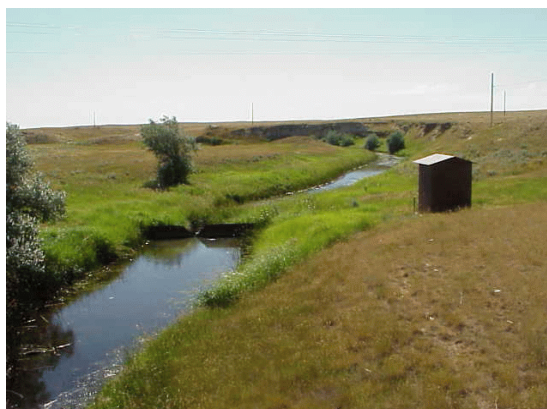
Figure 23: Caballo Creek

Caballo Creek is an official Wyoming geologic monitoring station. Figure 23 shows a picture of Caballo Creek at the monitoring station. Several hundred CBM wells have been discharging above the creek for over 12 years. The current discharge rate to this area averages approximately 3 to 4 gpm/well. A “v-notch” in the creek at this location is used to estimate the flow rate. Water monitoring data from this area indicate a decrease in total dissolved solids (TDS) and SAR for the last 10 years. CBM operators believe adding produced water to the drainage area has helped reduce TDS and SAR concentrations. Caballo Creek flows into the Belle Fourche River and into South Dakota. There are several small reservoirs approximately six miles downstream from this location that are used for irrigation.

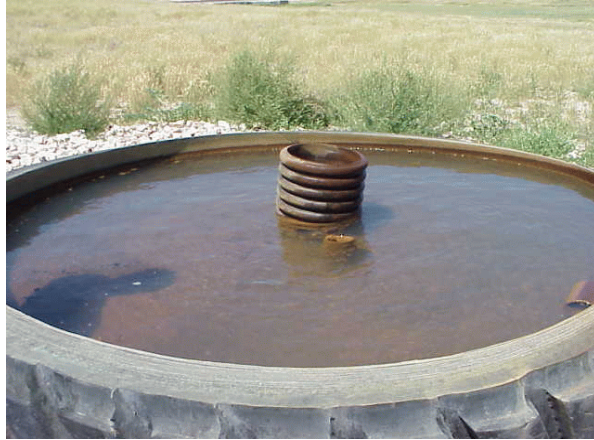
Figure 25: Tire Tank at Mankin Ranch

Phillips Petroleum is operating CBM wells at this location. Six newly installed CBM wells are discharging to the 21 Mile Butte Discharge point under NPDES Permit WY0038822. The produced water is piped to the tire tank and overflow is piped to the outfall location on Caballo Creek. Rocks around the tire tank were most likely installed to minimize the formation of mud as livestock drink from the tire tank. Figure 25 shows a picture of the tire tank. At the discharge point to Caballo Creek, the water flows out of a pipe onto limestone rocks to precipitate the dissolved iron. The rocks at the discharge point are also used to control/minimize erosion. Figure 26 shows a picture of the permitted outfall. Current flow from the discharge point is estimated at 15 to 20 gpm. Figure 27 shows a picture of Caballo Creek at the discharge point.

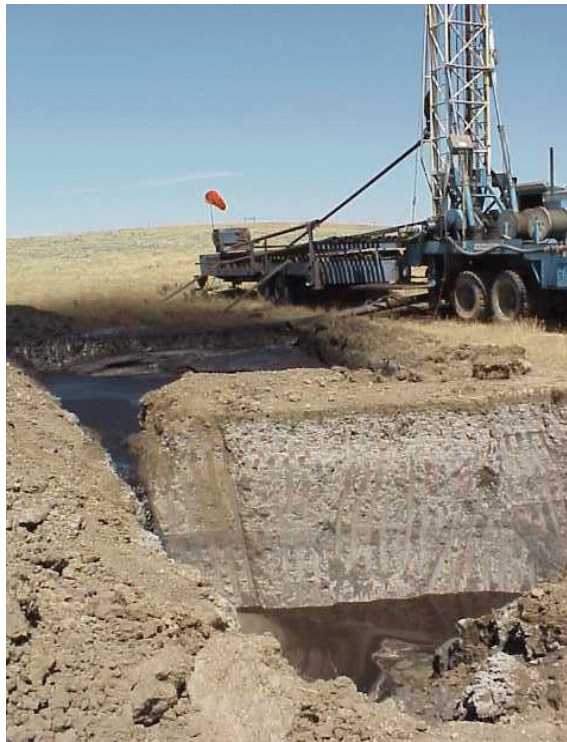
Figure 28: Truck-Mounted Drilling Rig at Saunders Drilling Site

The final stop on the site visit tour was to a CBM drilling site operated by Barrett Resources Corporation. All CBM wells in this area are drilled to the top of the coal seam using water and then drilled through the coal seam and underreamed with air. The depth to the Wyodak coal seam at this site is 1,163 feet and the depth to the bottom of the coal is 1,220 feet. Once the hole is completed the area is cleaned using a combination of air and soap that is discharged through a pipe into a temporary pit. This pit which contains some water, coal, and soap is backfilled and revegetated. Figure 28 shows a picture of the truck-mounted drilling rig and the temporary pit.
